# Manhole Inspection Summary

Manhole # S21GG\_043MH

Insp Date: **6/14/07 10:43 AM**

**Location** Address: **1611 MONROE-MCKEAN**

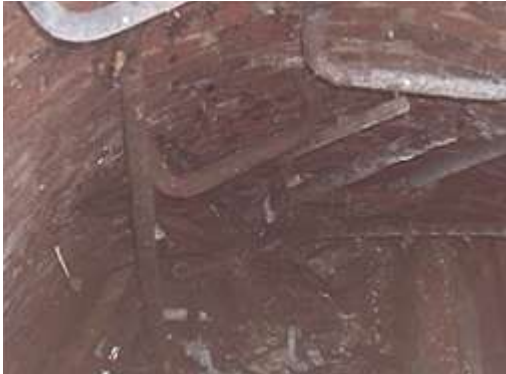
Defect 3

Count: **4** Missing: **0** ☒ **Corroded**

CORRODED STEPS

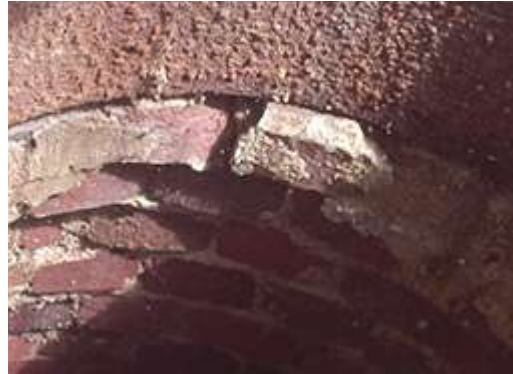
Defect 2

Condition: ☐ Sound ☐ Cracked ☐ Root Intrusion ☒ **Loose Brick** ☒ **Deteriorated**

DETERIORATION OF CHIMNEY AND  
LOOSE BRICKS

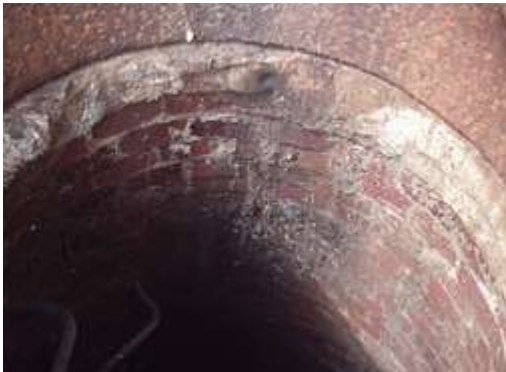
Defect 1

Infiltration: ☐ None ☐ Joint ☐ Cracks ☐ Mortar ☐ Roots ☒ **Wall**

INFILTRATION OF CHIMNEY

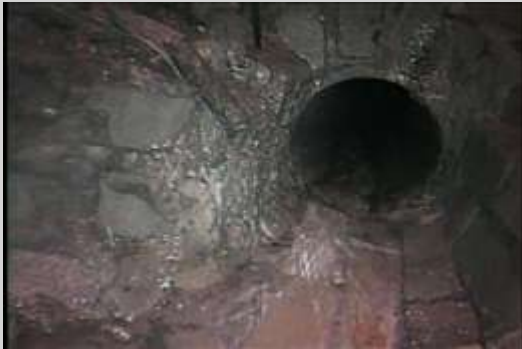
12 O'Clock Outflow

Pipe Height: **8.4** (in.) Rod and Bar (Angled)  
Pipe Material: **Clay** ☐ Pipe Lined  
Invert Depth: **10.13** (ft.) Flow Characteristics: **Slow**  
Deposits: ☒ None ☐ Mud ☐ Sludge ☐ Debris ☐ Grease  
Silt Depth: (in.) Deposits Extent:  
Infiltration: **None** Pipe Seal Cond: **Sound**

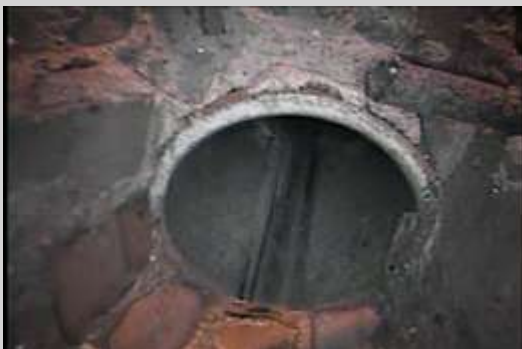
3 O'Clock Inflow

Pipe Height: **8.4** (in.) Rod and Bar (Angled)  
Pipe Material: **Clay** ☐ Pipe Lined  
Invert Depth: **9.94** (ft.) Flow Characteristics: **None**  
Deposits: ☒ None ☐ Mud ☐ Sludge ☐ Debris ☐ Grease  
Silt Depth: (in.) Deposits Extent:  
Infiltration: **None** Pipe Seal Cond: **Sound**

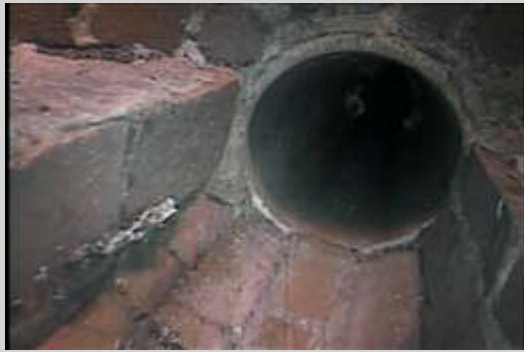
6 O'Clock Inflow

Pipe Height: **8.4** (in.) Rod and Bar (Angled)

Invert Depth: **9.81** (ft.) Flow Characteristics: **Slow**

Infiltration: **None** Pipe Seal Cond: **Sound**

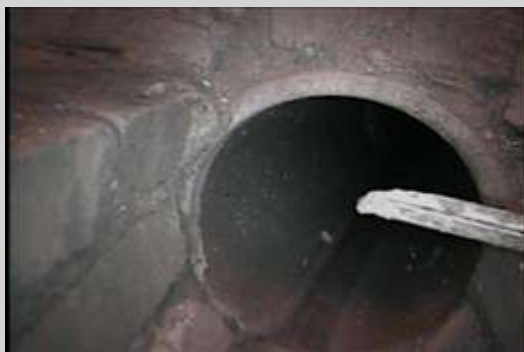
9 O'Clock Inflow

Pipe Height: **8.4** (in.) Rod and Bar (Angled)

Invert Depth: **9.86** (ft.) Flow Characteristics: **Slow**

Infiltration: **None** Pipe Seal Cond: **Sound**
